Soil Nailing and Slope Stabilization Work at Malabar Hill, Mumbai.

Project Summary: At Project Site Malabar Hill in D Ward Zone I the Existing Side Slope was failed due to land Slide by heavy Rainfall in Mumbai Region. The failed side slope location that was shown during Joint Visit by the Consultant, Contractor and client. The Working Area of failed side slope was 12000 sqm. The authorities have proposed Suitable method as below.

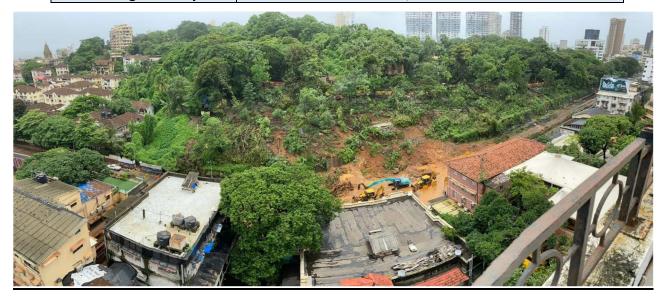
Site Photograph: Slope was failed due to land Slide by heavy Rainfall in Mumbai Region

Solution Details: Soil Nailing of upto 24m deep and 115mm Dia drilling have been done with Design angle, Safety point of view, and stability of slope and done for providing anchor for netting and erosion control mat. Erosion control mat is placed on the slope to control the soil erosion of slope and to produce natural vegetation and Greenery of area. Double Twisted netting is done to stabilized the slope and to support the erosion mat from getting failure.

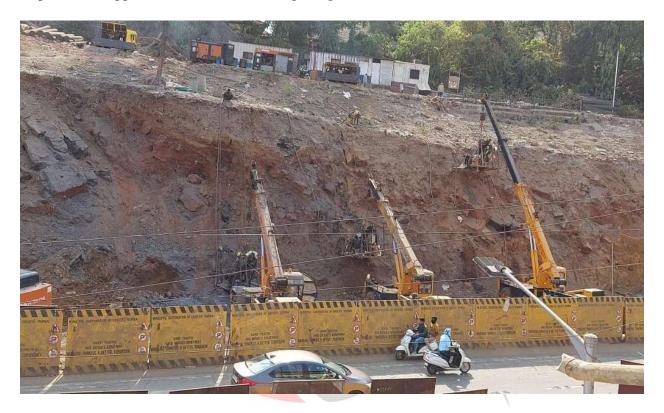
Site Photographs: Drilling at various locations

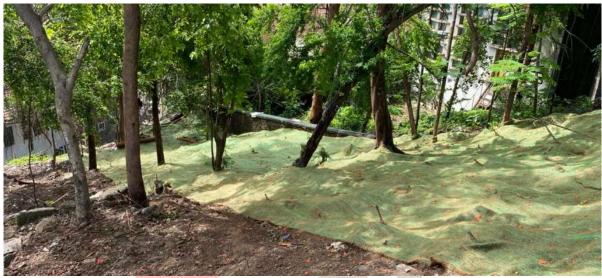
Site Photograph: Installing Erosion Control Mat

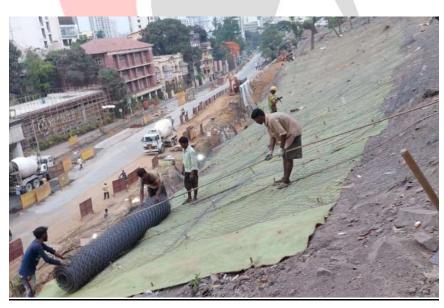
Site Photograph: Installing DT Netting Over Erosion Control Mat

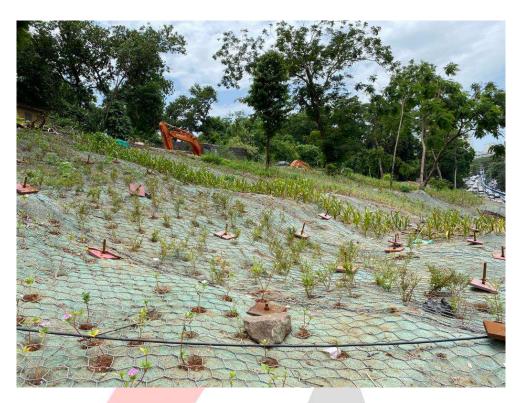
Site Photograph: Plantation of Vegetation on Slope

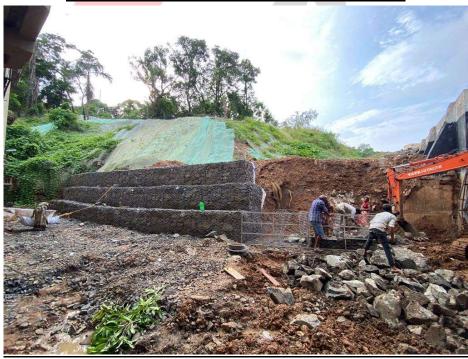
Site Photograph: Gabion Toe Wall

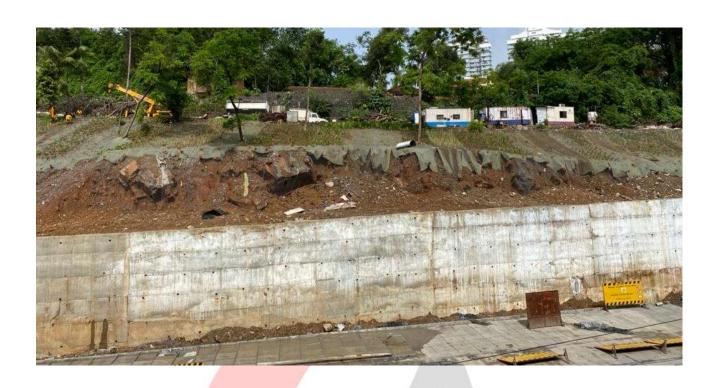
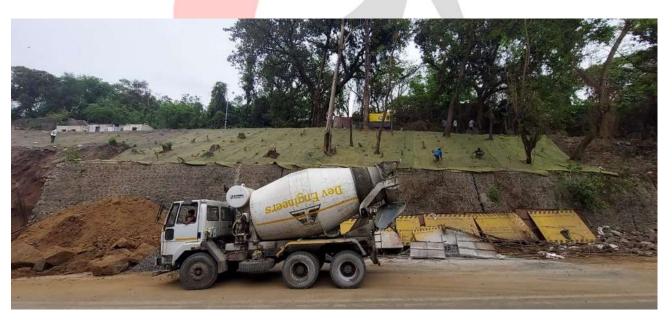
Site Photograph after Completion of work.
